**GEOTECHNICAL EVALUATION
CHAPEL HILLS WATER CAMPUS
MALLARD DRIVE AND STATE ROUTE 179
SEDONA, ARIZONA**

Arizona Water Company
7580 North Dobson Road, Suite 200
Scottsdale, Arizona 85256

Ninyo & Moore
Geotechnical and Environmental Sciences Consultants
3202 East Harbour Drive
Phoenix, Arizona 85034

October 31, 2016
Project No. 603971001

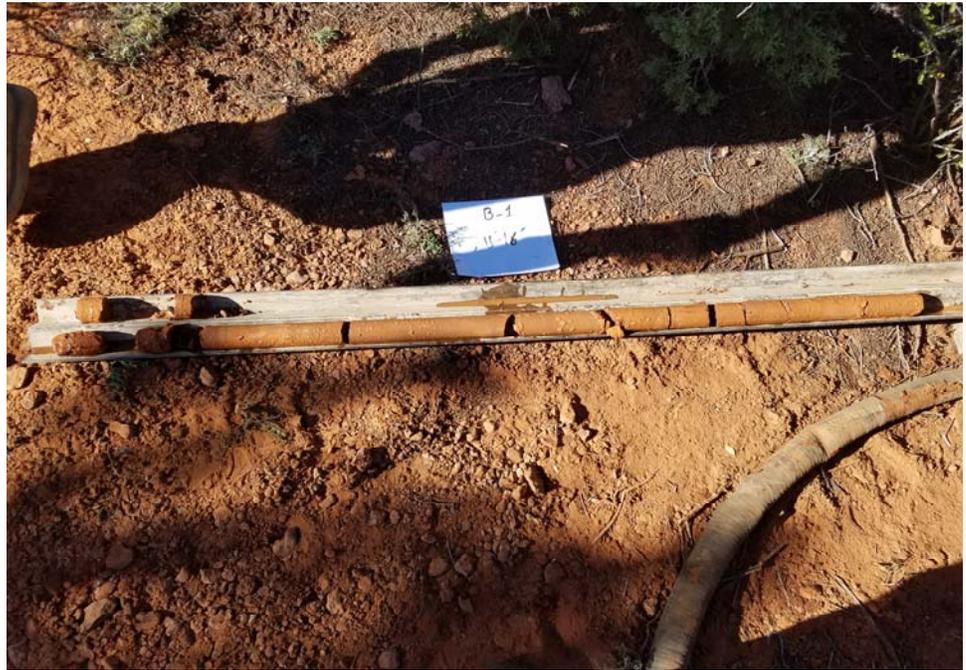
Photograph 1: Sample cores B-1, 11 through 16 feet.

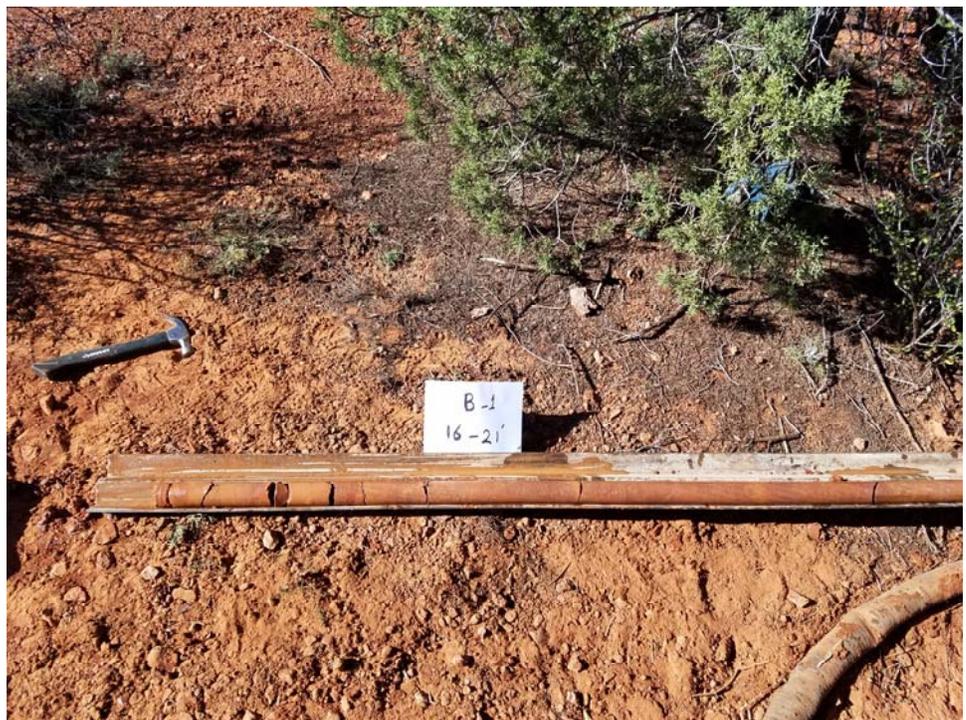
Photograph 2: Sample cores B-1, 16 through 21 feet.

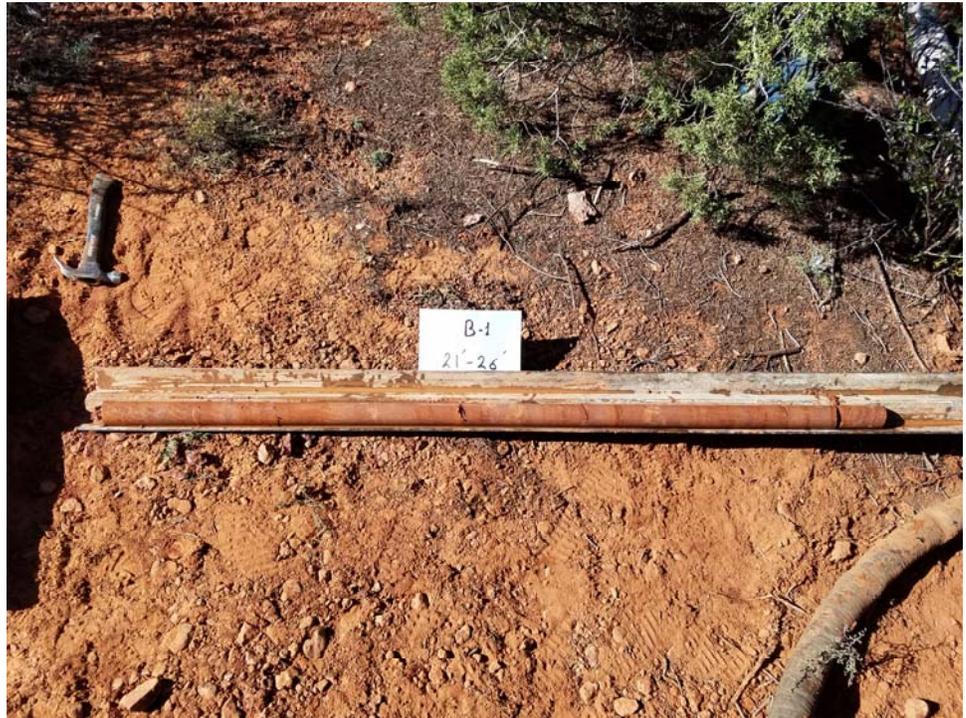
Photograph 3: Sample cores B-1, 21 through 26 feet.

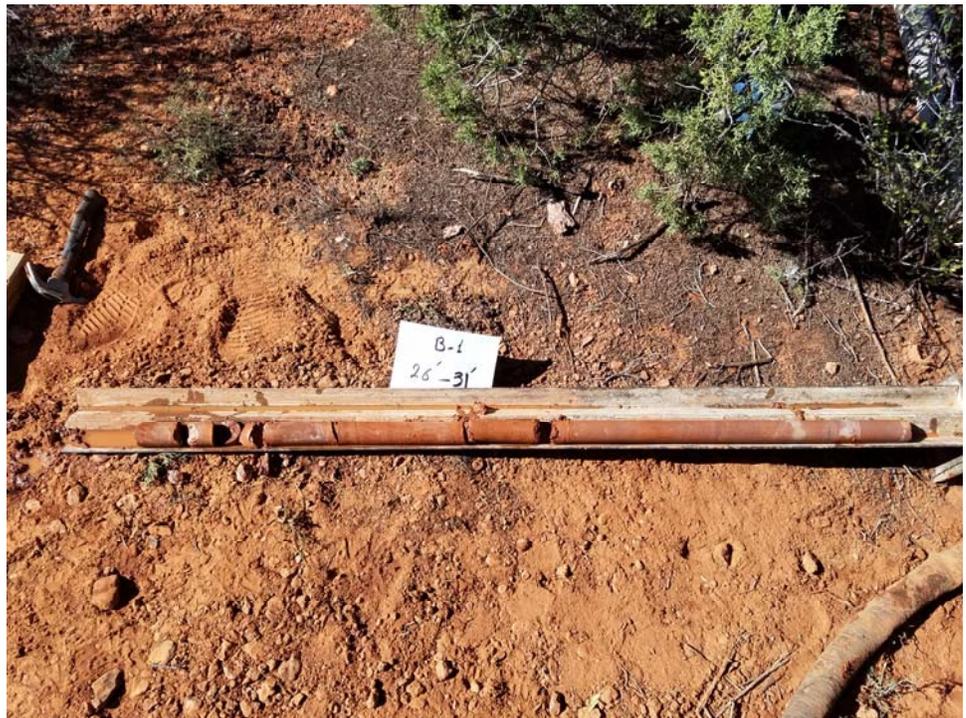
Photograph 4: Sample cores B-1, 26 through 31 feet.

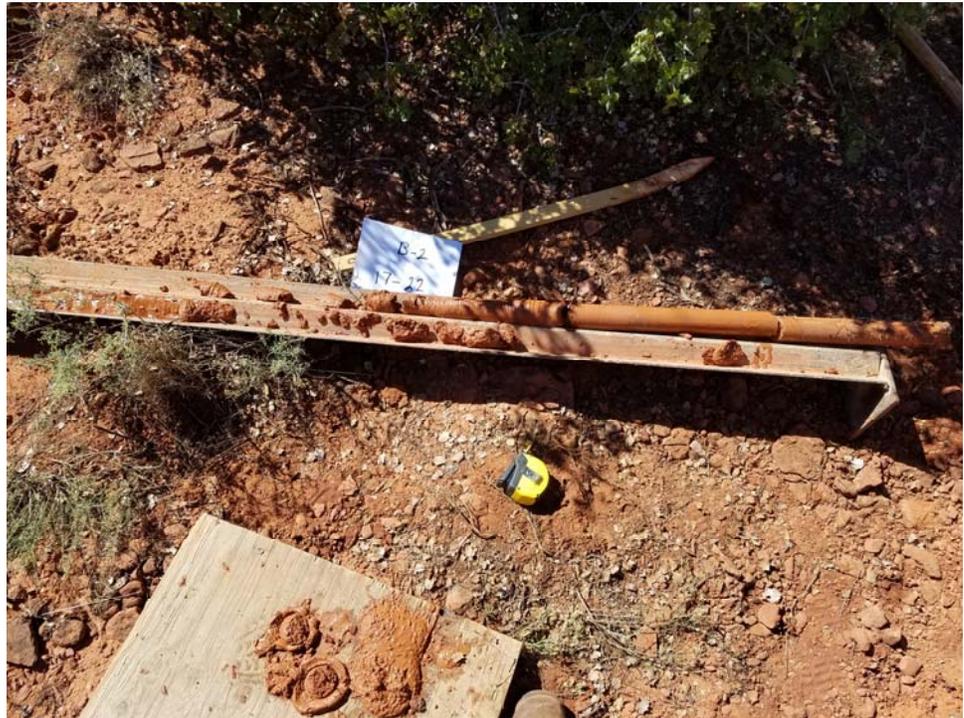
Photograph 5: Sample cores B-2, 17 through 22 feet.

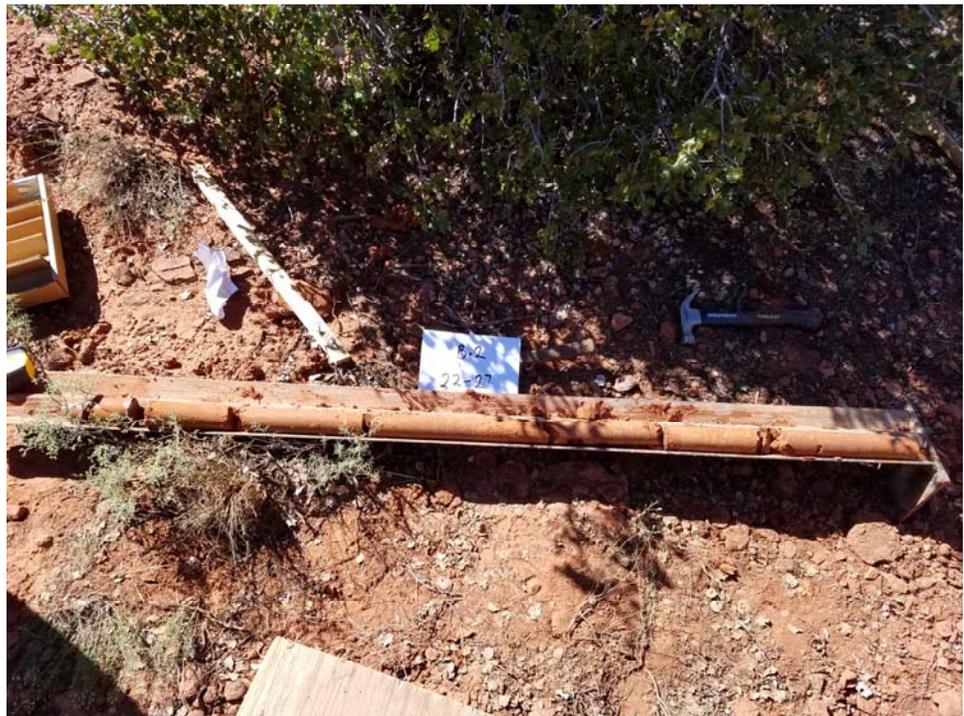
Photograph 6: Sample cores B-2, 22 through 27 feet.

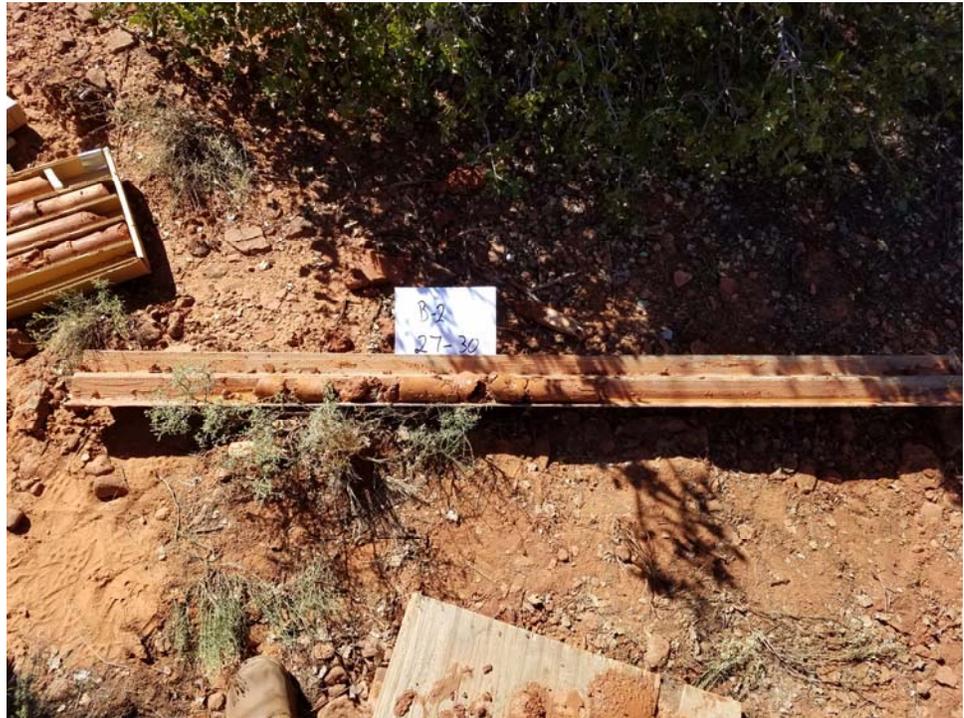
Photograph 7: Sample cores B-2, 27 through 30 feet.
